Maldives field survey of the 2004 Indian Ocean Tsunami

Hermann M. Fritz¹, Costas E. Synolakis^{2,3}, Brian G. McAdoo⁴ and Riccardo Caputo⁵

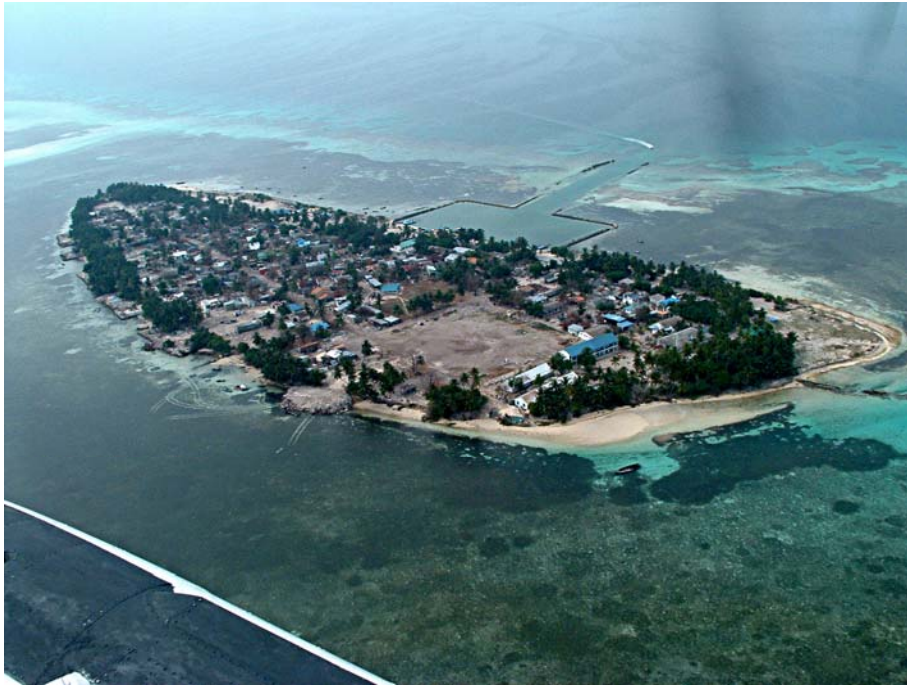
The Island of Vilufushi is located on the north-east corner of the Thaa Atoll facing Kolhufushi on Meemu Atoll across the narrowest part of the channel between Thaa and Meemu. The Island is shown from the air in Figure 4a). Vilufushi is barely 1 km long and up to 300 m wide. The island is bounded on the east by a coral reef located roughly 1 km offshore. The land is flat with an elevation of 1m. Vilufushi is one of the largest communities on Thaa-atoll with a population of 1886. Unfortunately, Vilufushi was the hardest hit individual island in the Maldives. As of this writing, the death toll remains at 18. In addition to the human loss 192 houses were damaged. Characteristic houses are

- Figure 4: Vilufushi Island (Thaa Atoll): (a) SW-view with the harbor towards the inner of the atoll taken during landing approach from the seaplane; (b) classic blow out failure of a corral stone wall.

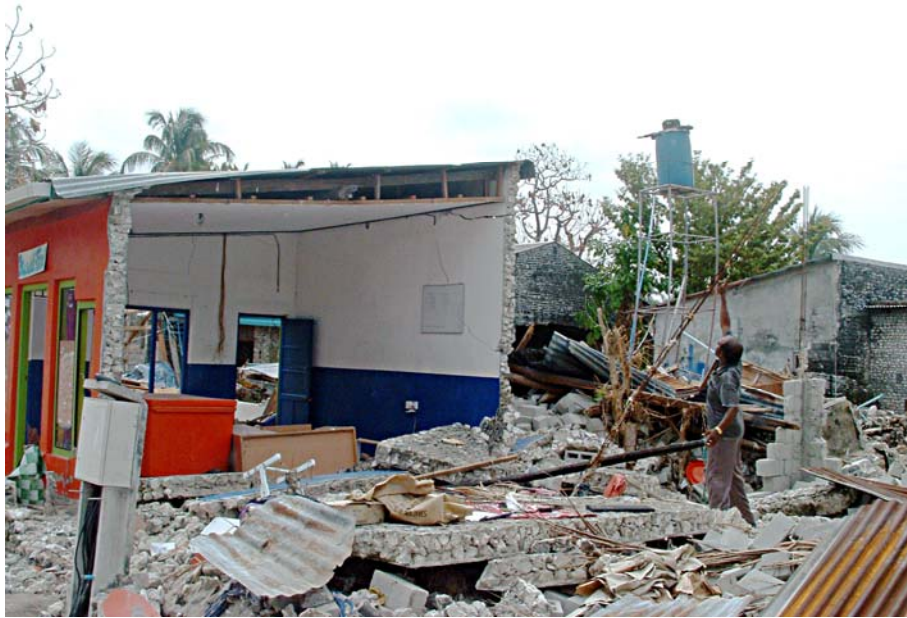
(b)

properly designed and built out of coral stones or concrete stones sometimes with steel reinforced concrete columns (as shown in Figure 4b). This is in sharp contrast to the wooden huts found along Sri Lanka's coasts (Liu et al., 2005).

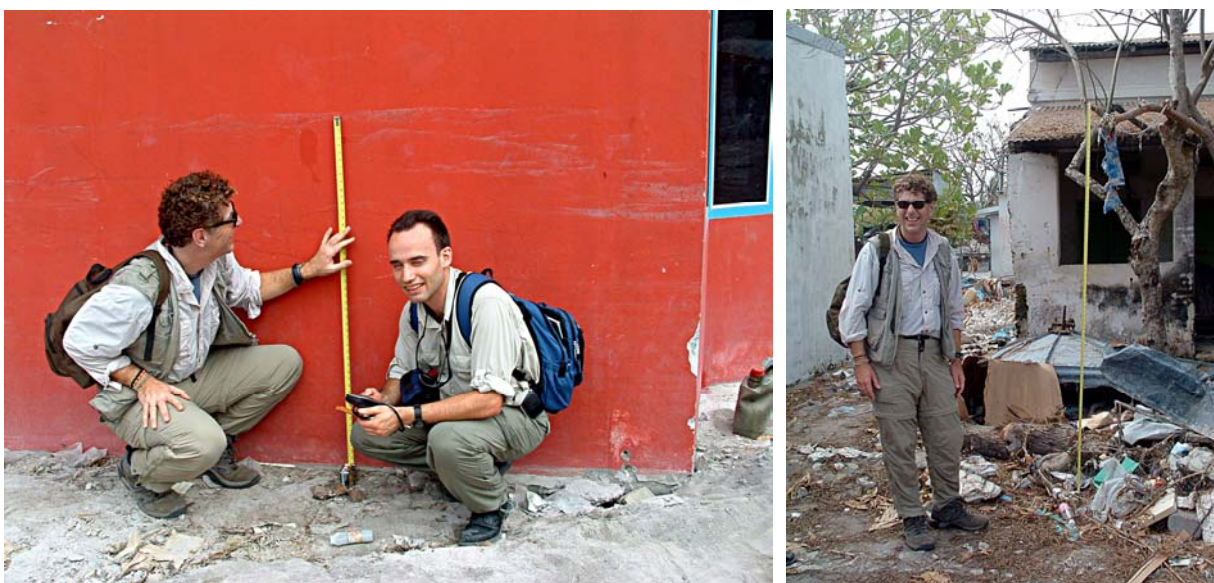
Figure 5

Vilufushi was completely washed over by the tsunami. Abundant watermarks were found on the outside and inside of remaining houses as well as in the form of seaweed, clothing and fishing nets on trees and concrete columns. Examples of tsunami flow depth measurements are shown in Figure 5.

- Figure 5: Flow depth measurements on Vilufushi: (a) watermark on an outside wall; (b) seaweed on a tree.
- Figure 6: Vilufushi: measured tsunami flow depths and surveyed locations on a pre tsunami satellite image provided by the Maldives Disaster Management Center.

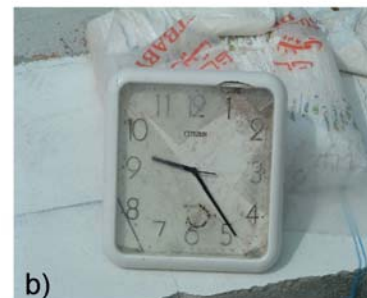
Several eyewitnesses were interviewed and recorded on video. Most inhabitants survived by fleeing in fishing boats towards the inner of the atoll, while others climbed to the roof of their houses and held on. The accounts generally mentioned one to four waves with a leading elevation in most cases. Some accounts mentioned an initial depression. The tide gauge records shown in Figure 7 all indicate an initial rise. The first wave arrived around 9:15 to 9:30 AM local time depending upon location within the island chain as indicated by the tide gauges shown in Figure 7. On the east coast of Vilufushi we recovered a broken clock, which stopped at 9:26 AM local time (= UTC + 5 hours). This is in agreement to the tide gauge records. Given the epicentral distances around 2600 km and taking into account the variable depth of the Indian Ocean Basin, travel times are expected to be 3.25 to 3.5 hours (Titov, 2005). With a seismic origin of 00:58:53 UTC, this predicts first arrivals around 9:15 to 9:30 local time, matching the initial rises on the tide gauge recordings as well as eyewitness accounts.

- Figure 7: Tsunami arrival time: (a) analysis of tide gauge residuals; (b) broken clock recovered on Vilufushi Island stopped at 9:26 AM local time (UTC + 5hr).

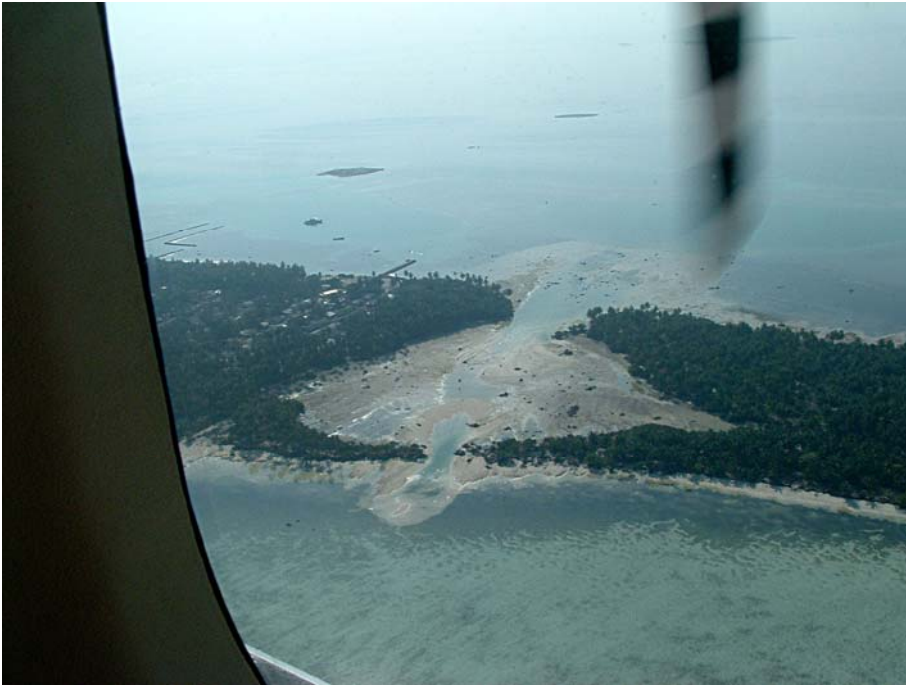
Kolhufushi is roughly 2.5 km long and 400 m wide. The transect recorded across the island indicates an even flow depth of 2 m above terrain across the entire island. The pre-tsunami satellite image shows a lagoon cutting into the island separating the northern third from the rest of the island. The two segments were connected by a narrow sand spit covered with vegetation along the eastern shoreline of the island. The sand spit had lost its vegetation and was partially breached prior to the tsunami. However the final breaching was induced by the overflow of the tsunami. The resulting cut separating the two island parts is shown in Figure 9 taken from the seaplane in final landing approach.

- Figure 9: Kolhufushi: aerial W-view of the lagoon and the sand spit, which was breached by the tsunami.
- Figure 10: Kandholhudhoo Island (Raa Atoll): (a) E-view of the island from the air; (b) collapsed sea-wall with exposed armor on the northwest side of the island.

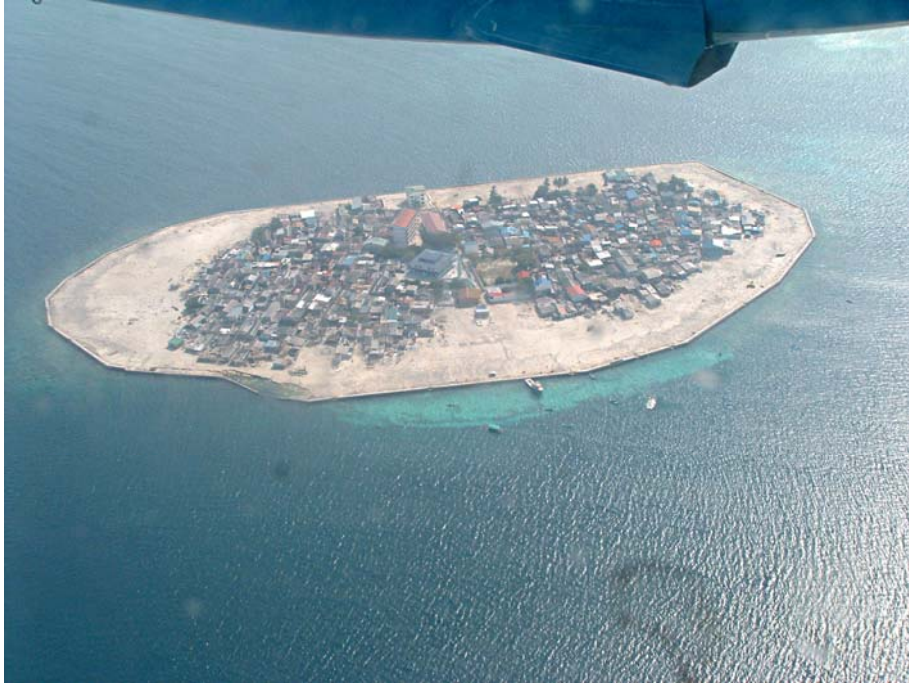
(a)

10 m depth between Kandholhudhoo Island and the center of the atoll protecting the island towards the east. The Island is shown from the air in Figure 10a. Kandholhudhoo is barely 500 m long and half as wide. Part of the island was reclaimed from the sea by the construction of an encircling seawall within the last 5 years, which partially collapsed due to tsunami induced erosion as shown in Figure 10b. The land is flat with an average elevation of 1.2 m relative to the sea level at the time the tsunami arrived.

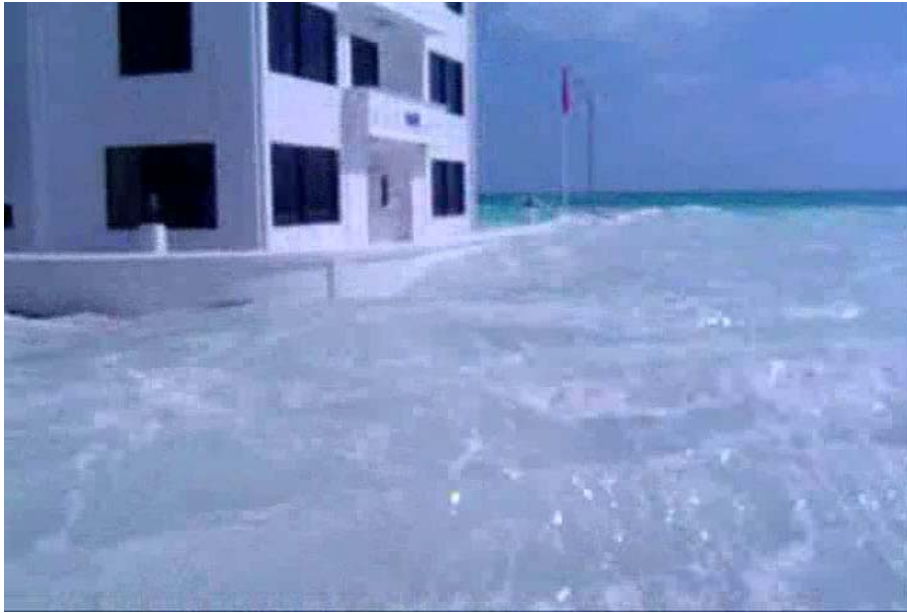
a)

On the eastside of Kandholhudhoo Island an amateur camera man – alerted by the phone call warning from Male – recorded the arrival of the tsunami. The position of the camera man looking to the east towards the center of the atoll is shown in Figure 11. The amateur video shows the initial rise of the tsunami flooding the streets similar to a rapid rise of the tides beyond normal high tide. An extracted video image during the flooding is shown Figure 12a. At a later stage the white wall disappears completely under water. The survey team revisited the exact location on January 19, 2005 and documented watermarks, a partially collapsed white wall and massive scouring along the road corner (Figure 12b).

- Figure 12: Kandholhudhoo amateur video: (a) during flooding by the tsunami; (b) video location in the aftermath with partial wall collapse and massive scouring.
